A34 Safety Review

Project Summary

September 2017

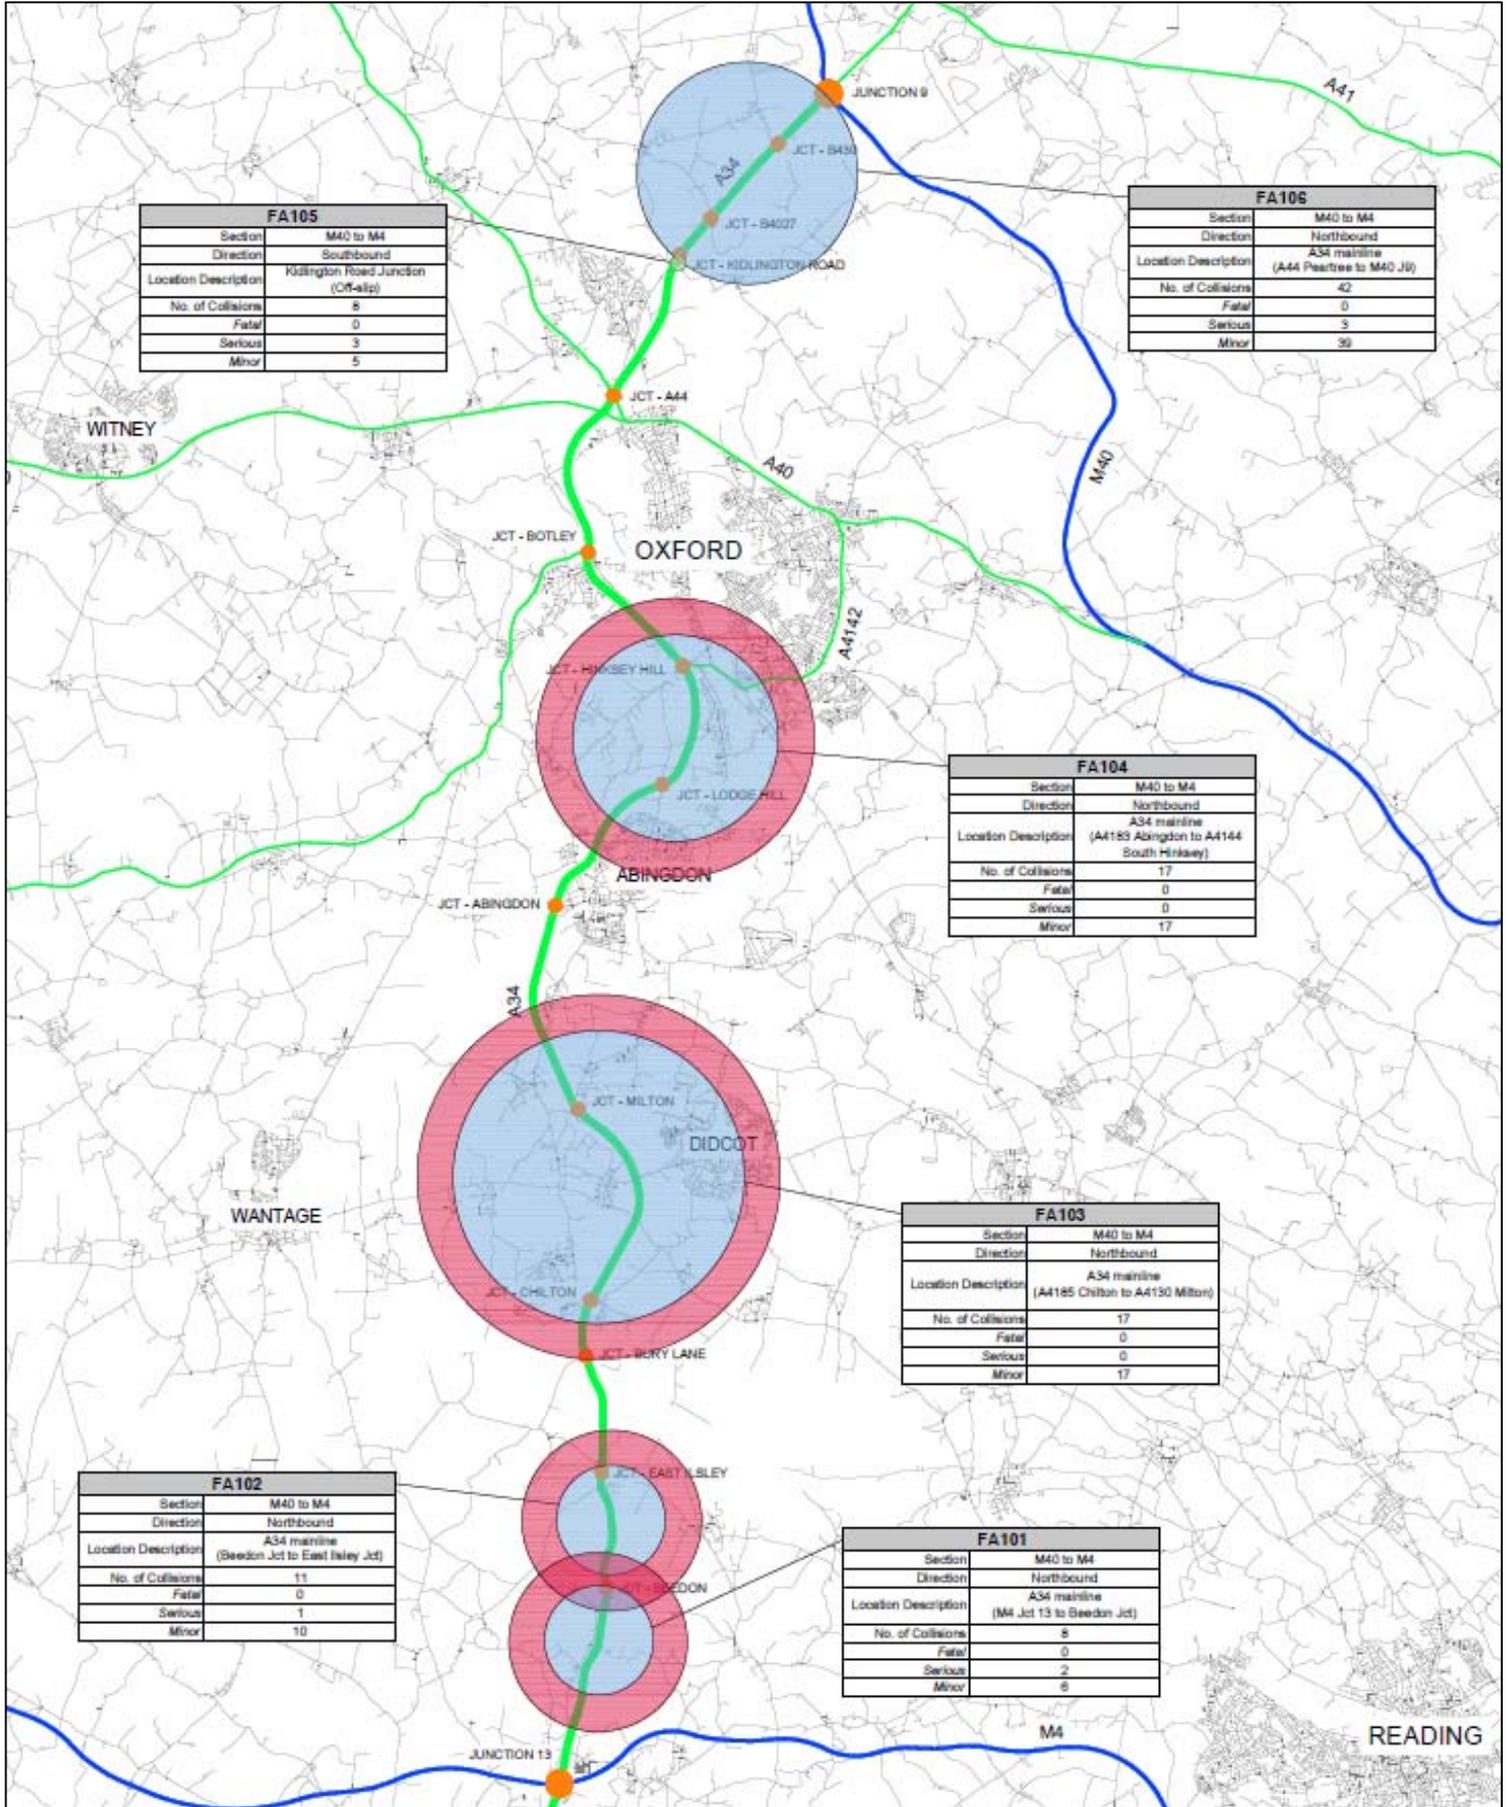
Figure 1 – Focus Areas

- Determine why collisions are happening in the identified Focus Areas (see figure 1) and identify packages of improvements that could be delivered in response to this review
- The packages will be identified by assessing the condition of the carriageway against the current standards.
- This is extracted from the A34 Safety Review, which is a technical report and the following is a non-technical summary.

7 focus areas were identified in this section of the route. The Focus Area at M40 Junction 9 was not taken forwards as it has previously undergone improvement works. Six were taken forwards further in the review, to explore any relationships between cluster areas and carriageway compliance. The six Focus Areas, shown in Figure 1, will inform any recommendations for improvements to the A34. Five of the focus areas were identified on the northbound carriageway and one on the southbound carriageway at Kidlington junction.

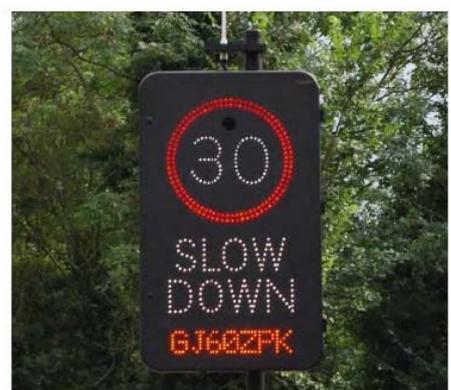
- Install innovative Vehicle Activated Signs (VAS) in the nearside and offside verge through Gore Hill.
- In the event of an abuse of the HGV ban VAS would have the ability to trigger a message such as "Get in Lane" in addition to highlighting the offender's vehicle registration number.
- The proposal looks to expand on pre-existing technology and explore an innovative version of it.

Figure 3 – Example of a Vehicle Activated Sign with ANPR

3 – Vehicle Activated Sign with Automatic Number Plate Recognition (ANPR) technology

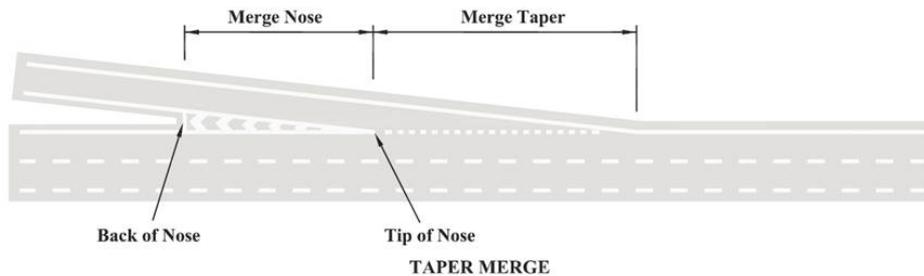
- The proposal is to reconfigure the junction arrangement to standardise the merge layout so that it is the correct length.
- Minimal carriageway widening would be required. This will allow vehicles to build up speed to match the speed of traffic on the A34.

Figure 4 – Proposed junction layout

4 - Improvements to the East Ilsley Junction

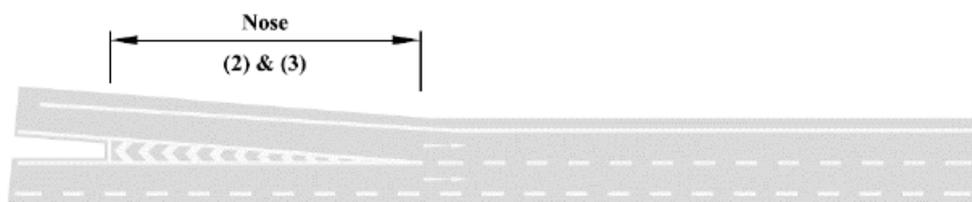
- Introduce a climbing lane, due to the steep gradient between East Ilsley junction and Bury Lane junction, for approximately 2km. The East Ilsley merge could be converted to a lane gain arrangement so that the joining traffic creates a third lane.
- This would increase overtaking capacity and safer exit of traffic at East Ilsley.
- However it should be noted that the traffic remerging back from lane 3 to lane 2 could pose an issue at the end of the climber lane, which would require further investigation into the safety benefits.
- This intervention was also identified by the Thames Valley Police report in 2016, produced following fatal collisions in the area.
- It should be noted that there is potential for adverse environmental impacts including sensitive noise and air receptors.

Figure 5 – Lane gain arrangement for climber lane

5 - Dedicated climber/ crawler lane
